# Manhole Inspection Summary

Manhole # S17I1\_006MH

Insp Date: **2/27/09 1:44 PM**

**Location** Address: **3053 LORENA AV**

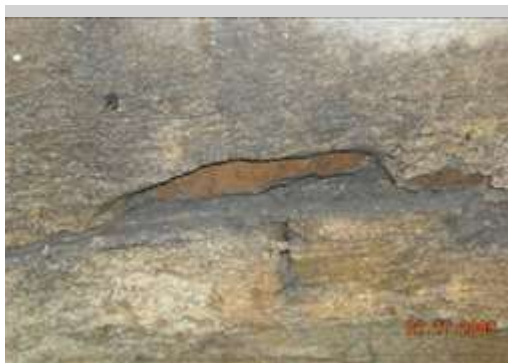
Defect 7

**Corbel** Material: **Brick** ☐ Parged Type: **Concentric/Eccentric**

Condition: ☐ Sound ☒ **Cracked** ☐ Root Intrusion ☐ Loose Brick ☒ **Deteriorated**

corbel crack at chimney joint

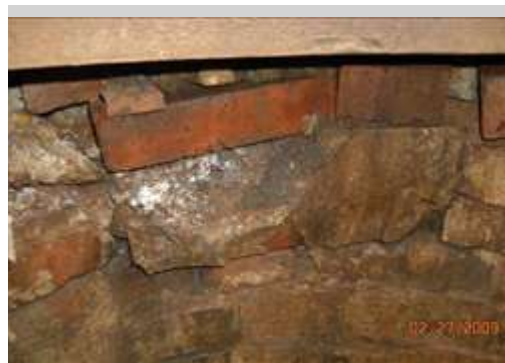
Defect 6

corbel deteriorated at chimney joint

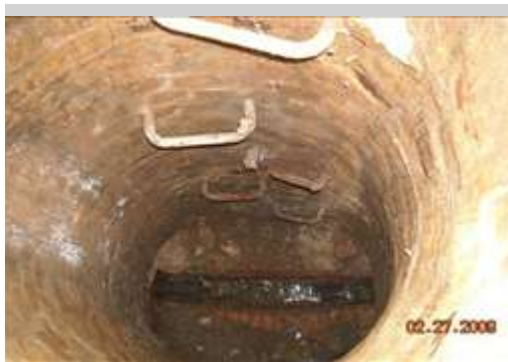
Defect 5

**Steps** Count: **5** Missing: **0** ☒ **Corroded**

steps corroded

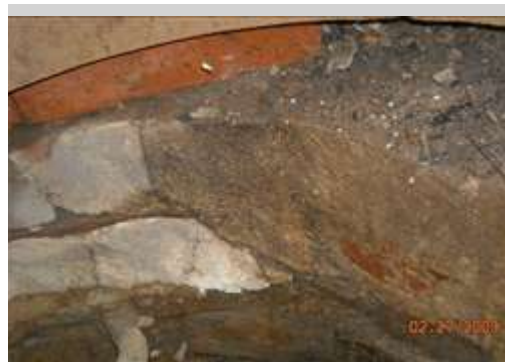
Defect 4

Infiltration: ☐ None ☒ **Joint** ☐ Cracks ☐ Mortar ☐ Roots ☐ Wall

chimney infiltration at frame joint

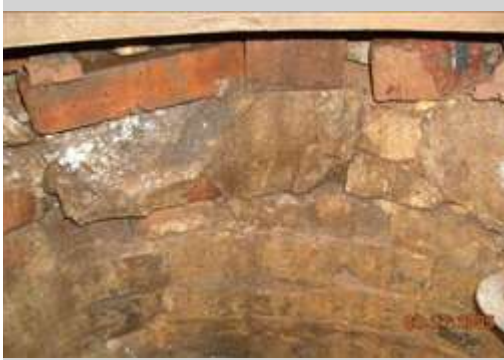
Defect 3

chimney loose bricks

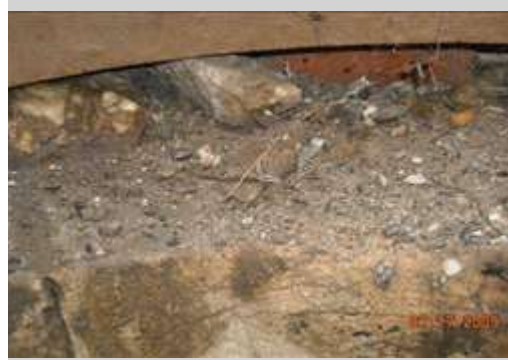
Defect 2

chimney deteriorated at frame joint

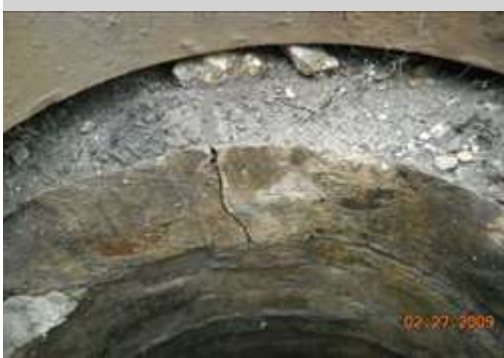
Defect 1

Condition: ☐ Sound ☒ **Cracked** ☐ Root Intrusion ☒ **Loose Brick** ☒ **Deteriorated**

chimney cracked

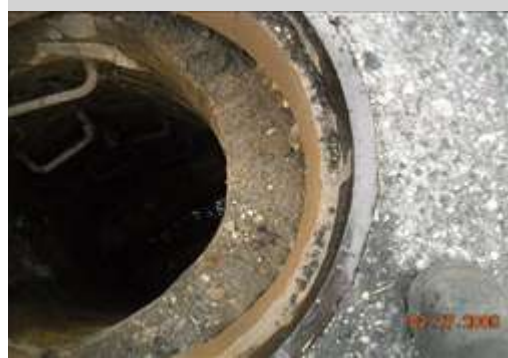
**Frame** Offset: **5** (in.) Condition: ☒ Sound ☐ Cracked ☐ Leaks

frame offset 5 inches

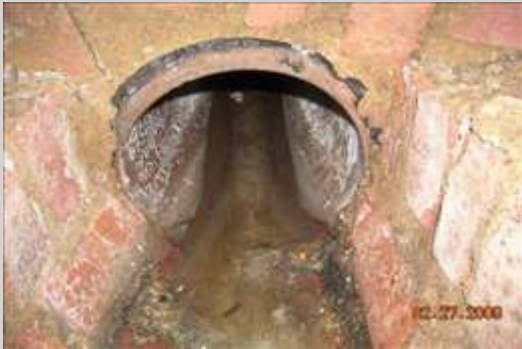
12 O'Clock Outflow

8 in. Circular Gravity Sewer  
Pipe Out @ 12 O'Clock

Pipe Height: **8.4** (in.) Rod and Bar (Angled)  
Pipe Material: **Clay** ☐ Pipe Lined  
Invert Depth: **10.30** (ft.) Flow Characteristics: **Slow**  
Deposits: ☒ None ☐ Mud ☐ Sludge ☐ Debris ☐ Grease  
Silt Depth: **0** (in.) Deposits Extent:  
Infiltration: **None** Pipe Seal Cond: **Sound**

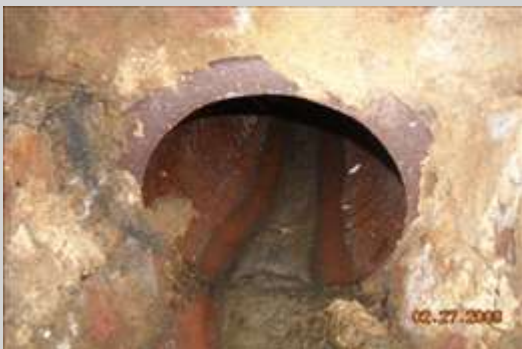
6 O'Clock Inflow

8 in. Circular Gravity Sewer  
Pipe In @ 6 O'Clock

Pipe Height: **8.4** (in.) Rod and Bar (Angled)  
Pipe Material: **Clay** ☐ Pipe Lined  
Invert Depth: **10.05** (ft.) Flow Characteristics: **Slow**  
Deposits: ☒ None ☐ Mud ☐ Sludge ☐ Debris ☐ Grease  
Silt Depth: **0** (in.) Deposits Extent:  
Infiltration: **None** Pipe Seal Cond: **Sound**
